HO-1049

4151 College Avenue
Private

Historic Properties Form

Inventory No. HO-1049

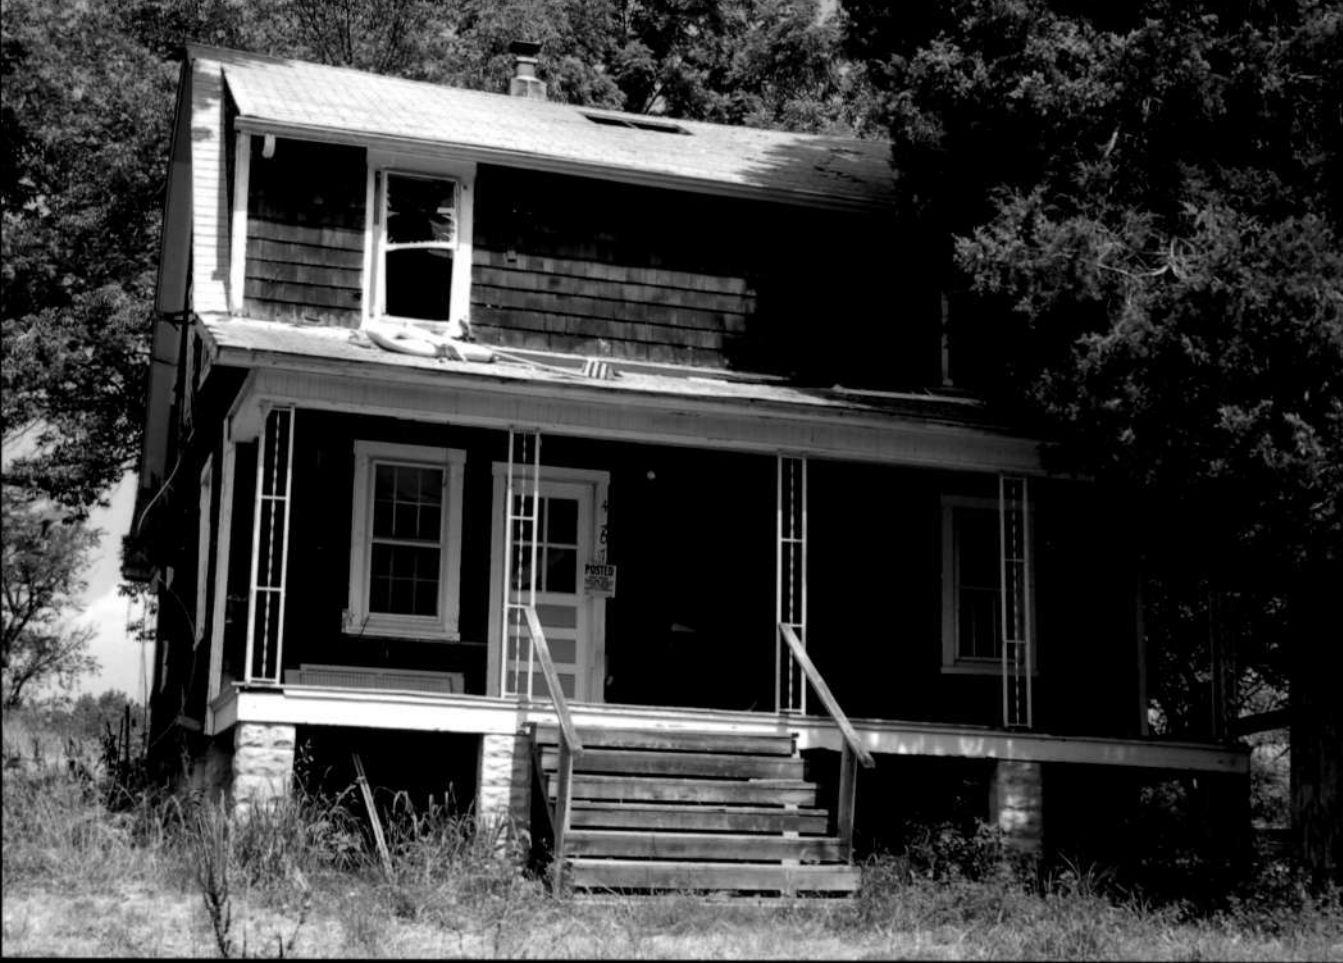
4151 College Avenue
Howard County, Maryland
Ken Short
2011-07-20
MD SHPO
Southeast elevation
1 of 4

The southeast elevation has a raised basement with a five-lying panel door, and there are steps down to it on the southwest side of the porch. The first story has a wood six-over-six sash in both end bays, with head-cut trim, and these are typical for the house. There is a door set south of center that has four lights over three lying panels. There is a three-bay, one-story porch set on rock-faced concrete block piers, and it has a tongue-and-grooved wood deck, new metal posts, and a bead-board soffit. The second story has a six-over-six sash in the end bays that have been broken out. There is an interior parged chimney in the center, set northwest of the ridge. There are wide boxed eaves.

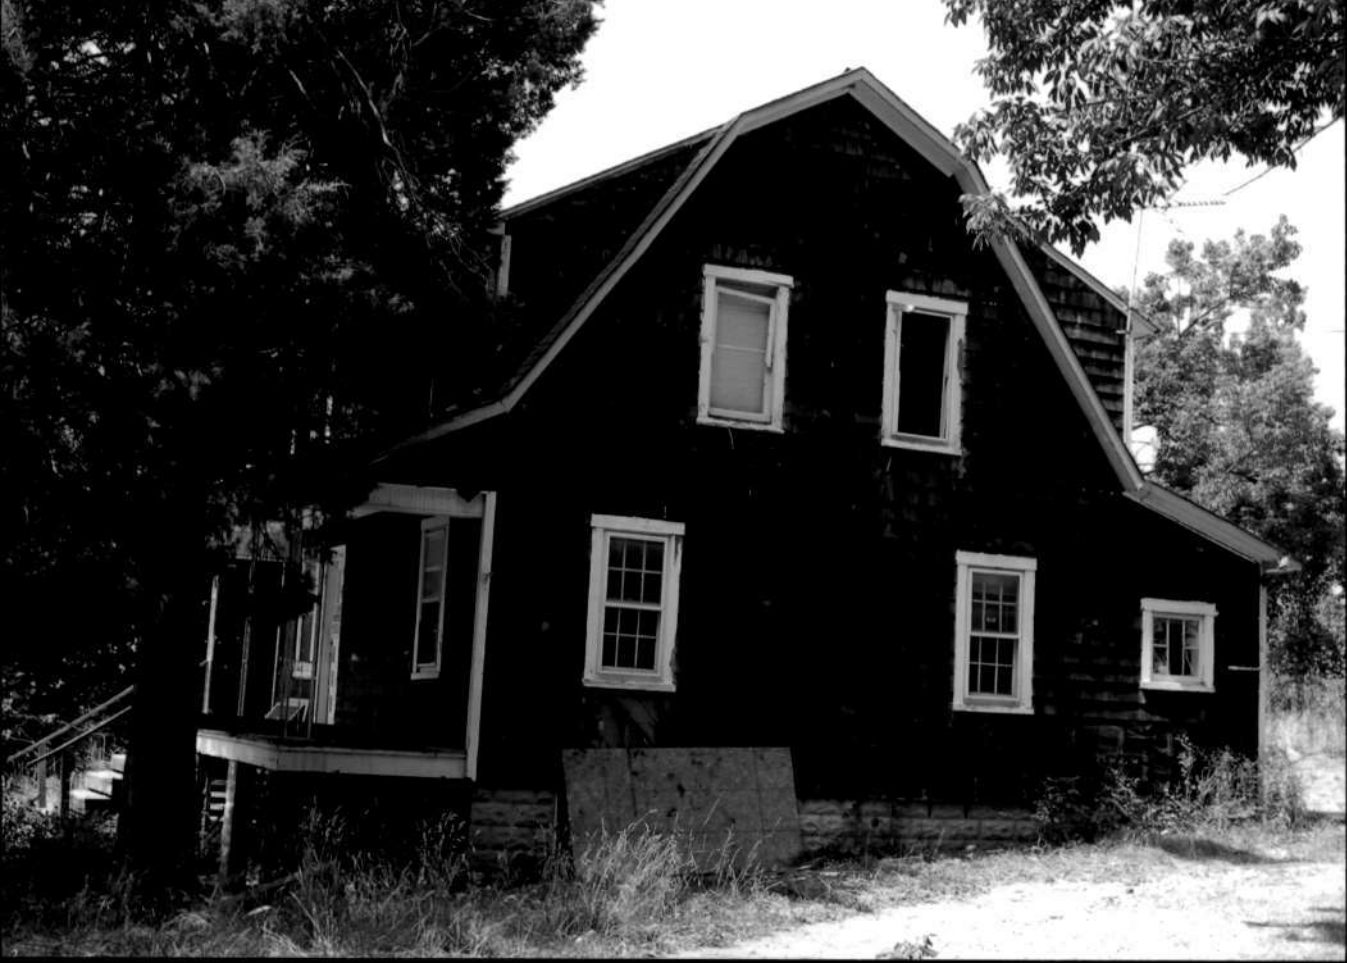
2 of 4

The northeast elevation has two typical six-over-six sash on the first story. There is a shed-roofed porch on the northwest that is enclosed at the northeast end and has a six-light casement. The "gambrel" end has two six-over-six sash that are broken out.

Northeast elevation

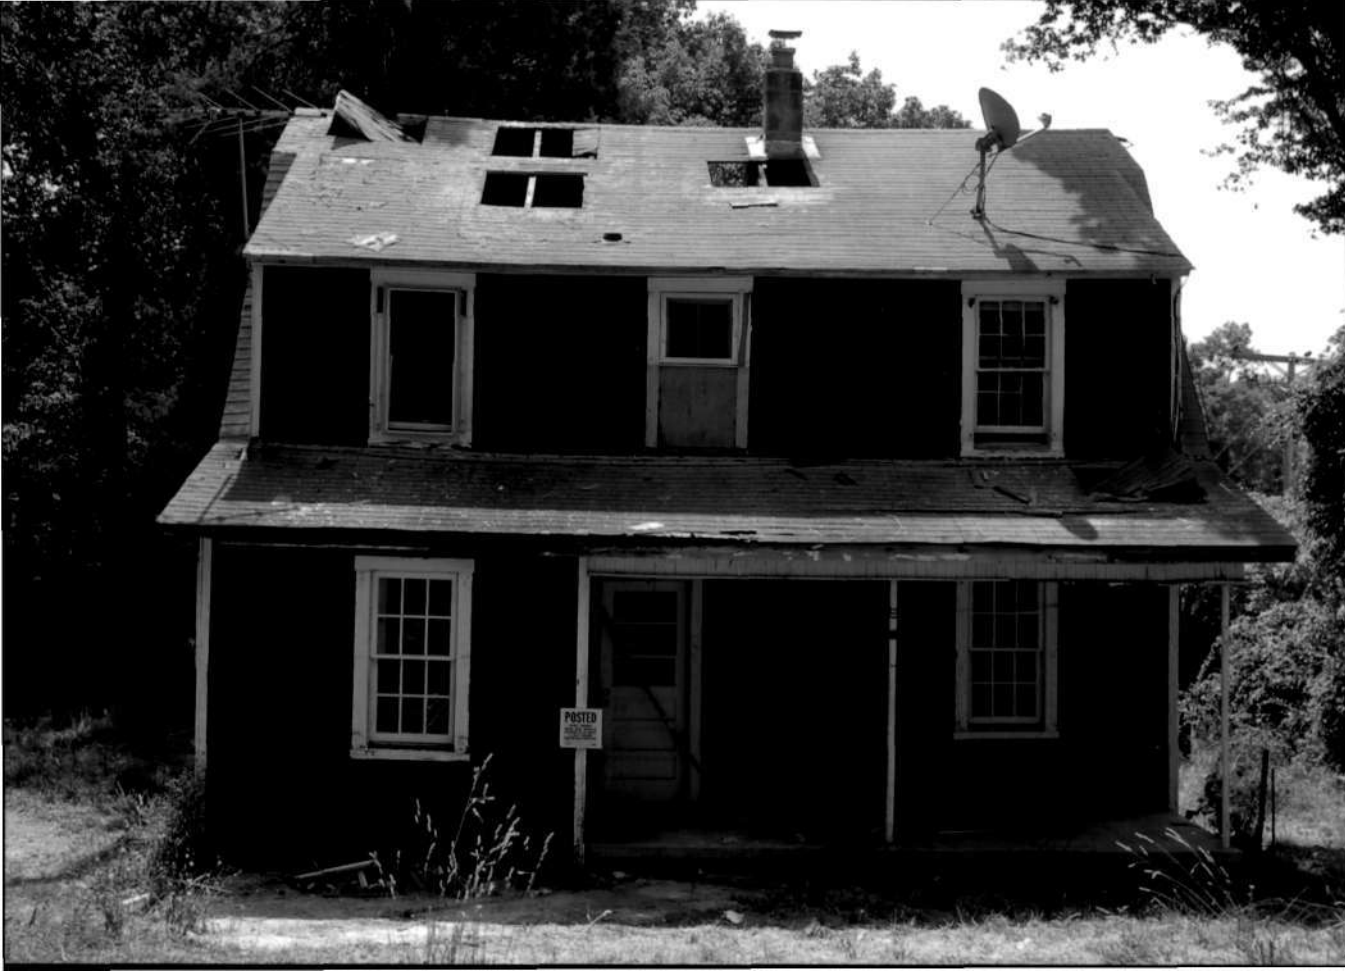
3 of 4

The northwest elevation, on the first story, has a typical six-over-six sash in the enclosed porch of the north bay. The center bay has a door with three lying lights over three lying panels, and the west bay has a typical six-over-six sash. The second story is missing its sash from the north bay. The center bay has a modern sash above plywood infill, and the west bay has a typical six-over-six sash.

Northwest elevation

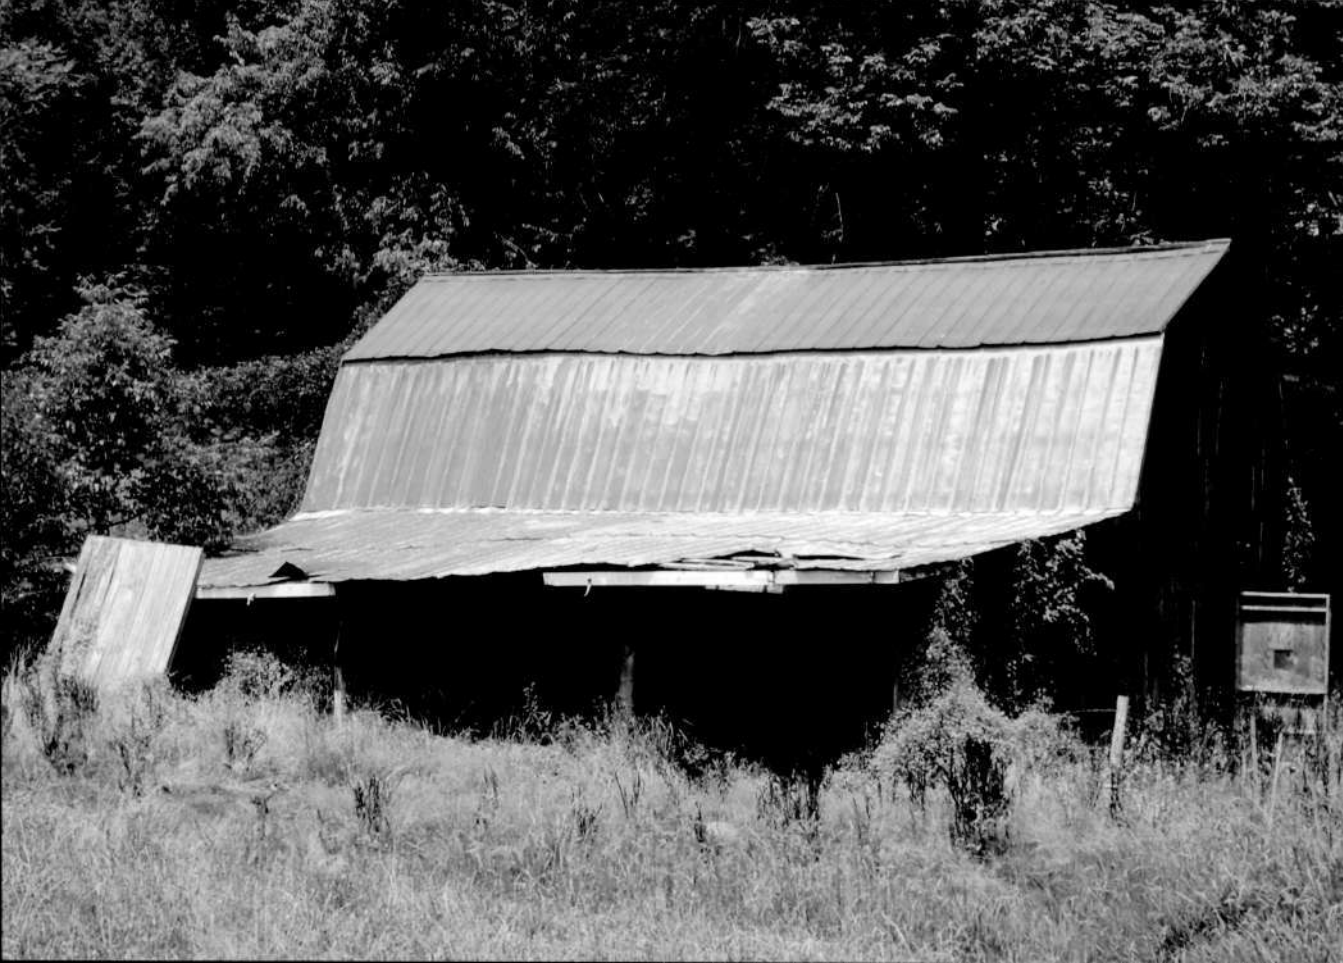
4 of 4

The stable is located about 500 feet northwest of the house and over the ridge from it, and is set about 150 feet southeast of the road, on the northwest side of a small stream or spring. The ground slopes up to the northwest, southeast, and southwest around the stable. The building is a one-story, one-bay by one-bay frame structure with the foundation hidden and board and batten siding. The gambrel roof has a northeast-southwest ridge and inverted-v-seam metal. The southwest elevation is completely overgrown with vines. The southeast elevation has a shed-roofed addition, and the original wall of the stable has been in-filled with scrap material. The northeast elevation has a plywood door set north of center. The northwest elevation has one window cut in, to the north of center, with one large light. The building is racking to the northwest. The interior has a center summer beam that runs northeast-southwest, with an aisle to the northwest and stalls to the southeast. It is constructed of circular-sawn 2 by 4s that are wire-nailed, with some logs used as posts. The rafters are lapped and nailed to the sides of the joists, without either being cut.

Stable, southeast + northeast elevations
